PRATT AND WHITNEY AIRCRAFT GROUP WEST PALM BEACH FL 6--ETC F/6 11/6  
SCALE-UP OF A TITANIUM CARBONITRIDE COATING SYSTEM FOR TITANIUM--ETC(U)  
JUL 80 L S SOKOL, C C MCCOMAS DAA646-77-C-0057

PWA-FR-11897

AMRC-TR-80-39

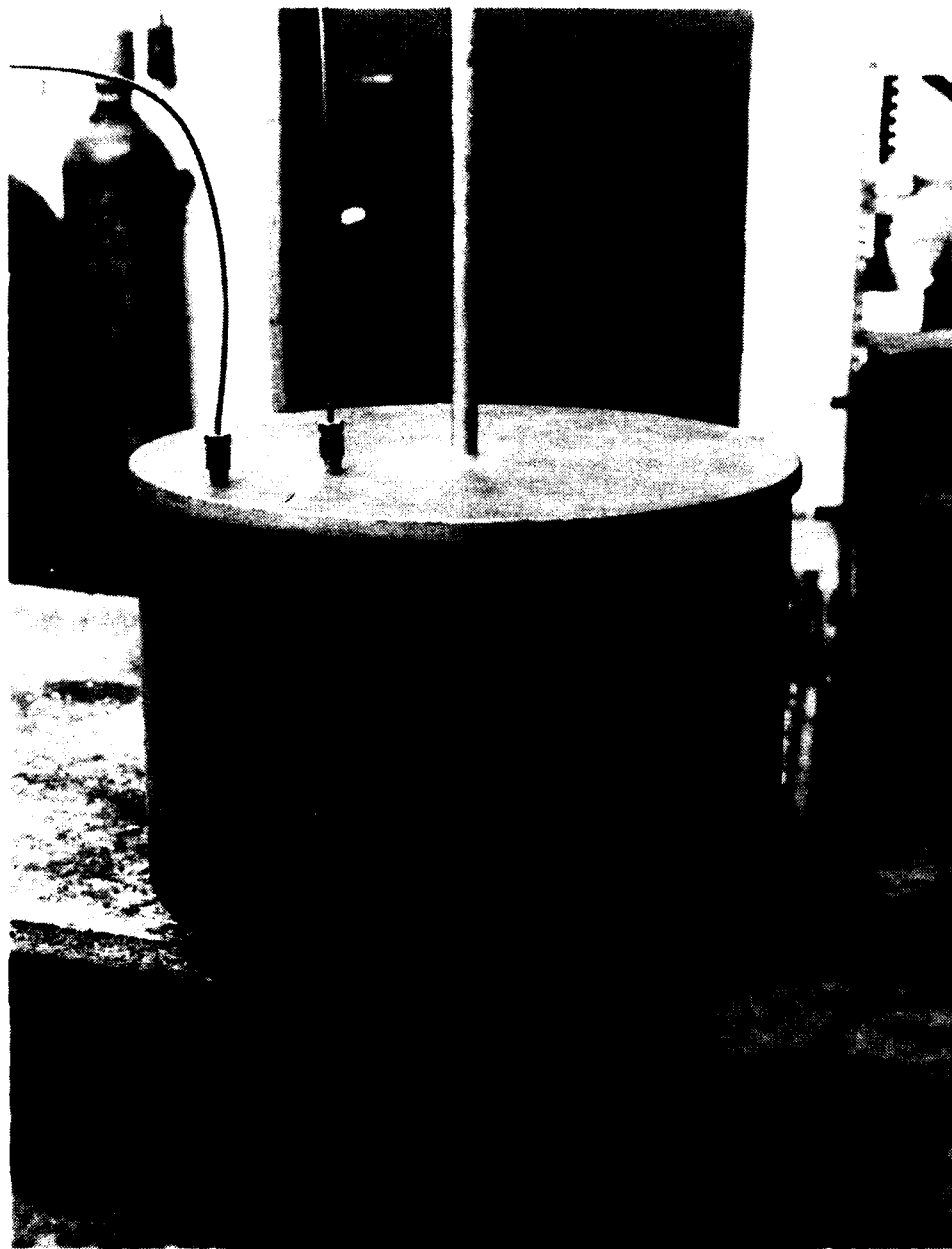
*Figure 23. Metal Can Used as Furnace Chamber*

Since the TiCN does not bond well to stainless steel, cleaning the chamber out after each run can be accomplished with minimal effort.

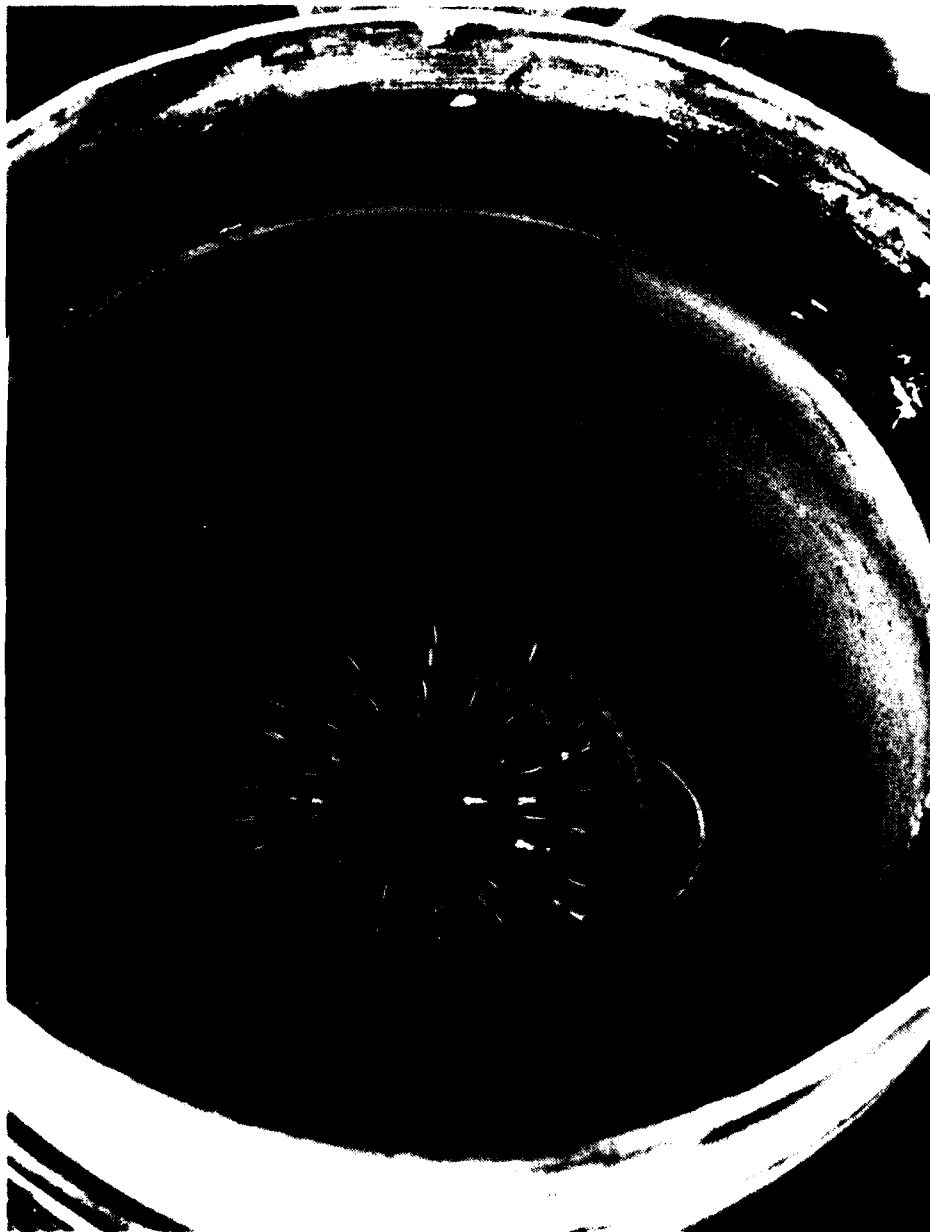
*Figure 25 - Blades Positioned in Furnace Chamber*

4. Distribution of gas flows and gas inlet temperatures was found to be a key variable in this process. Insulation at the top of the furnace was changed to increase or decrease the gas temperature as it entered the furnace chamber. Different types of baffle plates were tried to distribute the gas evenly, and the parts to be coated were positioned at different levels in the chamber. The conditions that gave the best results were an inlet temperature of 650°C, an inlet baffle plate 2 in. in diameter 1 1/2 in. below the inlet to the chamber and the parts positioned 4 to 5 in. below the baffle plate.
